**ASTM E 90 SOUND TRANSMISSION LOSS  
TEST REPORT**

**ETO DOORS CORPORATION**

**TYPE: Side-Hinged Single Door System**

Report No: B2385.01-113-11  
Test Date: 08/10/11  
Report Date: 08/24/11  
Expiration Date: 08/10/15

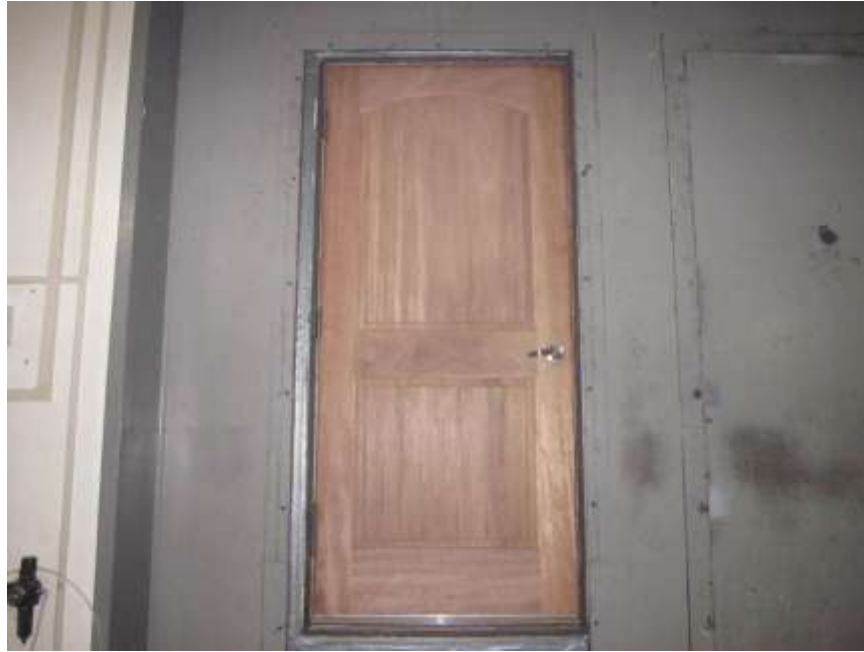
**Receive Room View of Installed Test Option A**

The specimen plug was removed from the filler wall assembly, and the door system was placed on an isolation pad in the test opening. Duct seal was used to seal the perimeter of the test specimen to the test opening on both sides. The interior side of the door frame, when installed, was approximately 1" from being flush with the receiving room side of the filler wall. A stethoscope was used to check for any abnormal air leaks around the test specimen prior to testing. The door panel was opened and closed at least five times prior to testing.

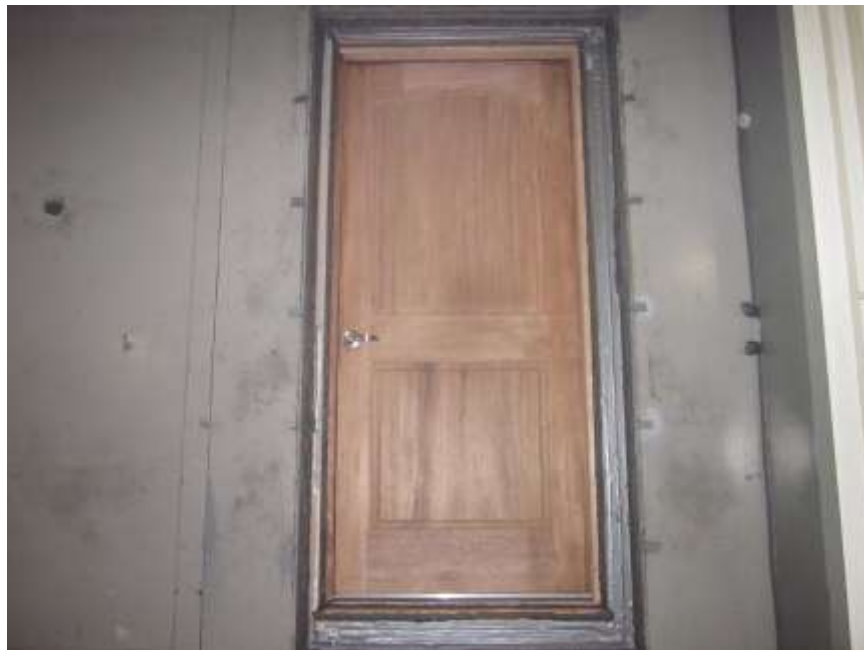
**Source Room View of Installed Test Option A**

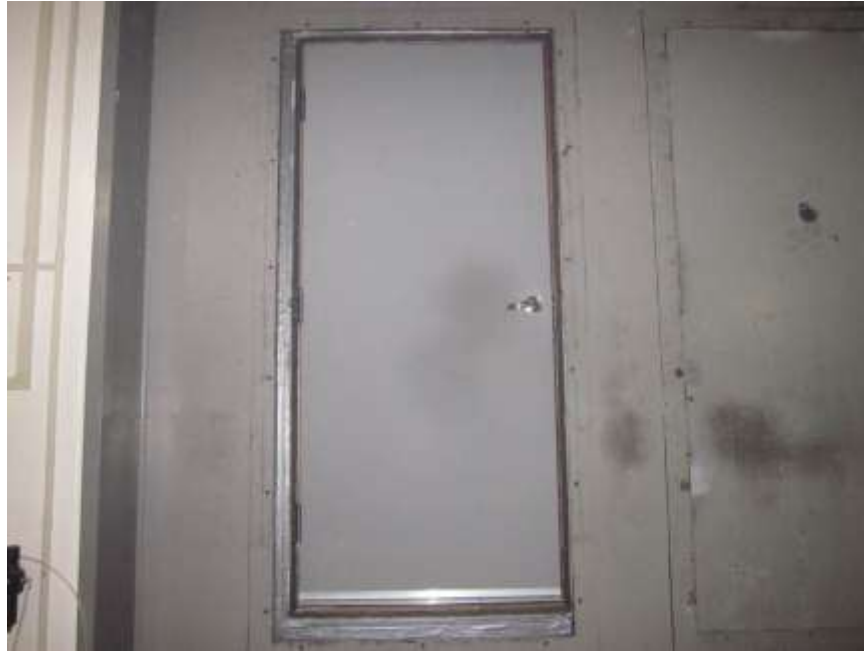
**Receive Room View of Installed Test Option B**

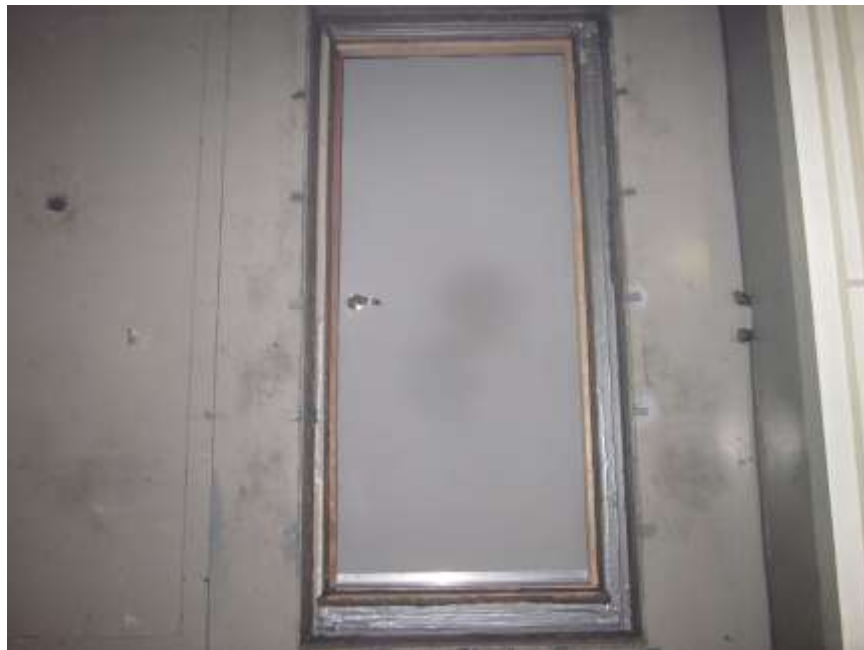
**Source Room View of Installed Test Option B**
